Addendum No. 6

**ITB No. 16-21
REMOVE, DISPOSE, AND REPLACE WINDOWS AND TRIM AT
THE ROCKDALE COUNTY COURTHOUSE**

**Report of Limited Suspect Asbestos Building Materials Survey
Window Pane Glazing & Frame Caulking**

**Rockdale County Courthouse
922 Court St NE
Conyers, GA 30012**

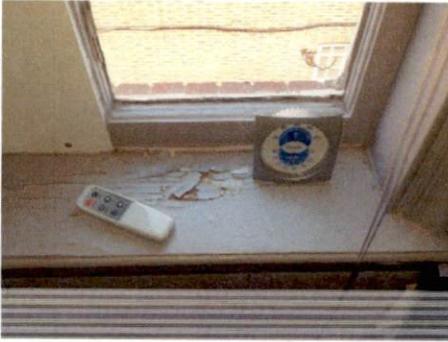
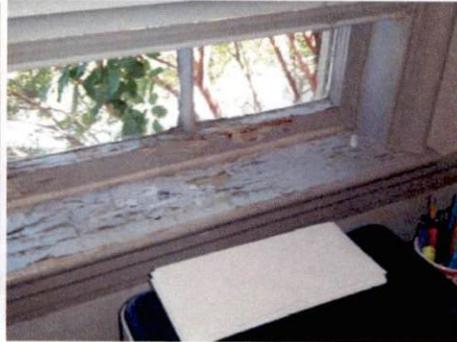
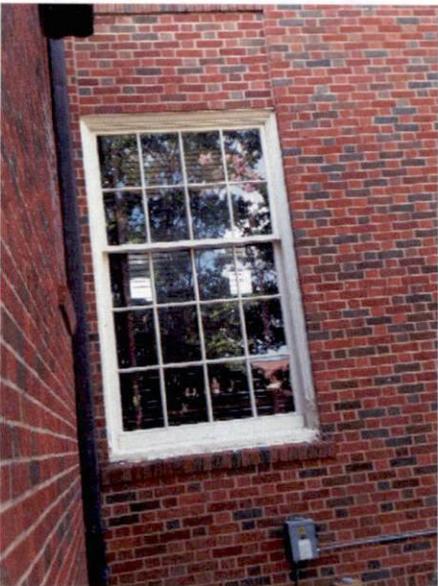
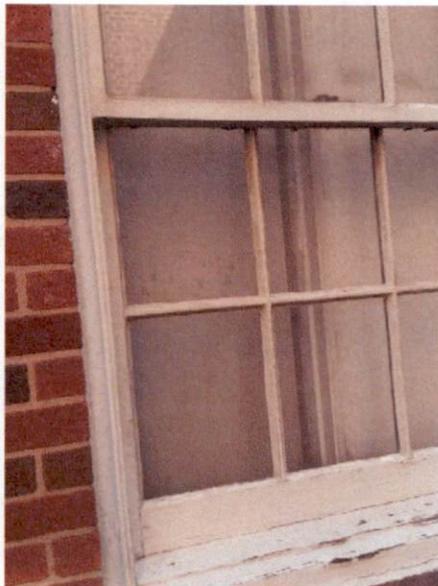
Photographic Documentation

SLC performed a total of forty-two (42) XRF assays of representative painted surfaces and performed six (6) instrument calibrations. Fifteen (15) of the XRF assays of the identified a lead concentration above the HUD regulatory limit of 1.0 mg/cm² lead by XRF, or within the Positive parameters of 0.6 mg/cm² - 1.1 mg/cm² as defined by the Performance Characteristics Sheet (PCS) for the Innov-X instrument. Results of XRF assays and specific information related to each XRF assay are attached. Identified positive components;

- Interior and exterior window sashes, window casings and window sills
